Manhole Inspection Summary

Manhole # S09A1_004MH

Insp Date: **5/14/08 8:55 AM**

Location Address: **3601 Benson Ave**

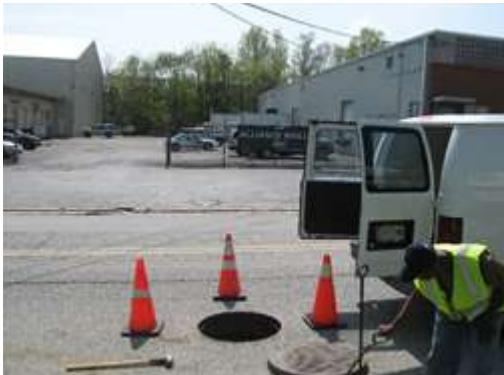
Location View

Across from 3605 Benson Ave

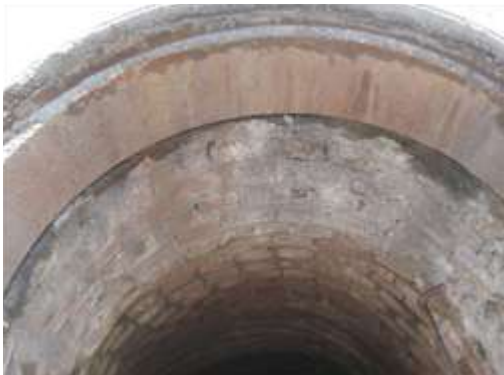
Defect 2

Infiltration: ☐ None ☒ **Joint** ☐ Cracks ☒ **Mortar** ☐ Roots ☐ Wall

Infiltration from top and under chimney

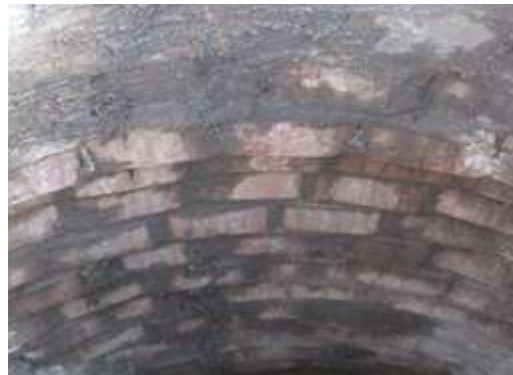
Defect 6

signs of infiltration frame lid connect

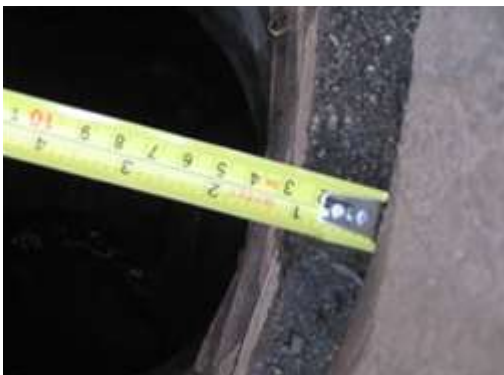
Defect 4

Offset: **1.** (in.)
25

offset 1.25

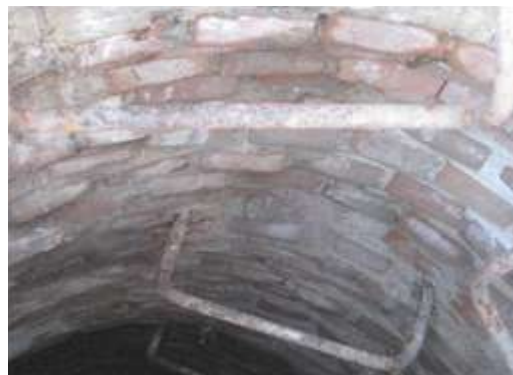
Defect 2

Count: **8** Missing: **0** ☒ **Corroded**

oxidized rungs

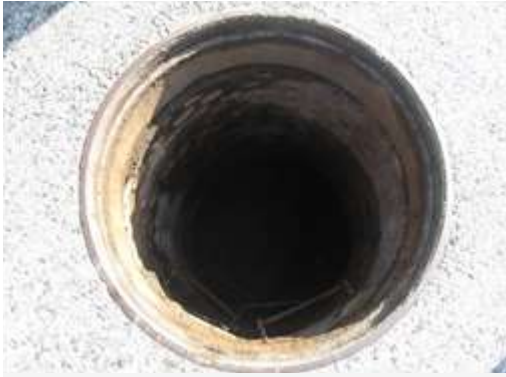
Defect 7

Condition: ☐ Sound ☐ Cracked ☒ **Leaks**

frame leaks

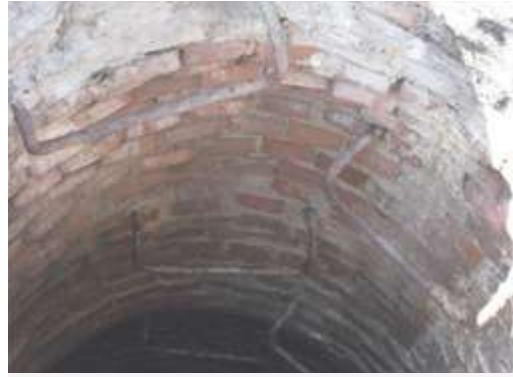
Defect 1

Condition: ☐ Sound ☐ Cracked ☐ Root Intrusion ☐ Loose Brick ☒ **Deteriorated**

oxidized rungs and chimney deterioration

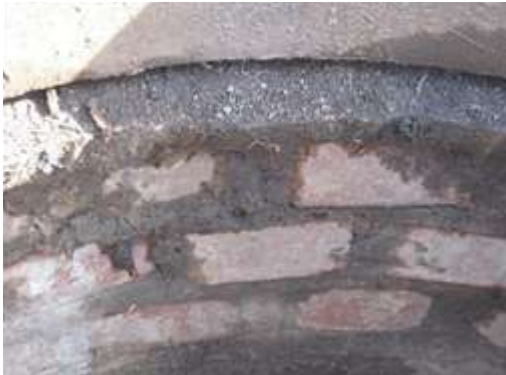
Defect 5

1.25 inches as well as signs of infiltration
frame-chimney connect

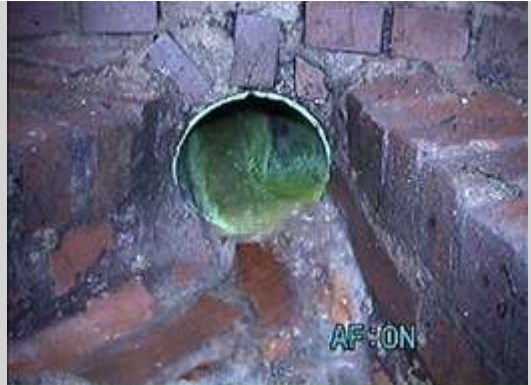
12 O'Clock Outflow

Pipe Height: **8.4** (in.) Rod and Bar (Angled)
Pipe Material: **PVC** ☐ Pipe Lined
Invert Depth: **13.20** (ft.) Flow Characteristics: **Fast**
Deposits: ☒ None ☐ Mud ☐ Sludge ☐ Debris ☐ Grease
Silt Depth: **0** (in.) Deposits Extent:
Infiltration: **None** Pipe Seal Cond: **Sound**

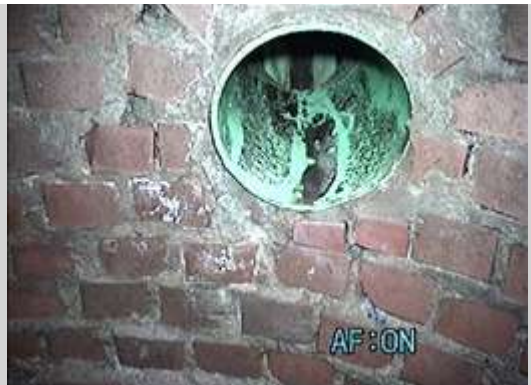
3 O'Clock Inflow

Pipe Height: **8.4** (in.) Rod and Bar (Angled)
Pipe Material: **PVC** ☐ Pipe Lined
Invert Depth: **10.50** (ft.) Flow Characteristics: **Fast**
Deposits: ☒ None ☐ Mud ☐ Sludge ☐ Debris ☐ Grease
Silt Depth: **0** (in.) Deposits Extent:
Infiltration: **None** Pipe Seal Cond: **Sound**

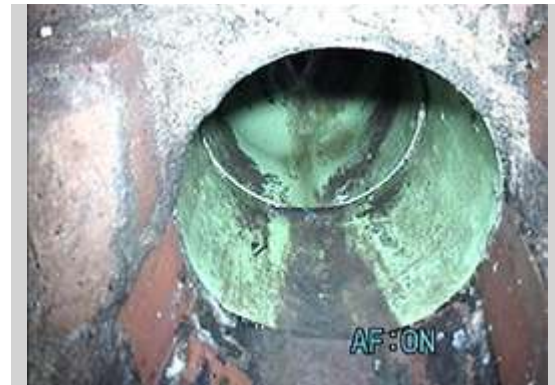
Drop In @ 3 O'Clock

Drop: **Outside** Rod and Bar
Angled: **Yes** Reading: **12.10** (ft.)
Inv Depth: **13.10** (ft.)

Drop Condition: **Open**

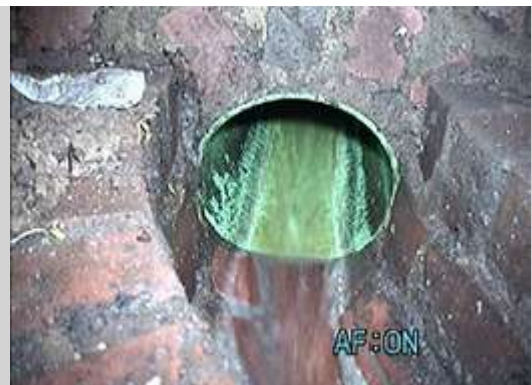
9 O'Clock Inflow

Pipe Height: **8.4** (in.) Rod and Bar (Angled)

Pipe Material: **PVC** ☐ Pipe Lined

Invert Depth: **13.00** (ft.) Flow Characteristics: **Slow**

Infiltration: **None** Pipe Seal Cond: **Sound**
